How to Prevent Procon Pump Failure and Diagnose Problems

PUMP ANALYSIS

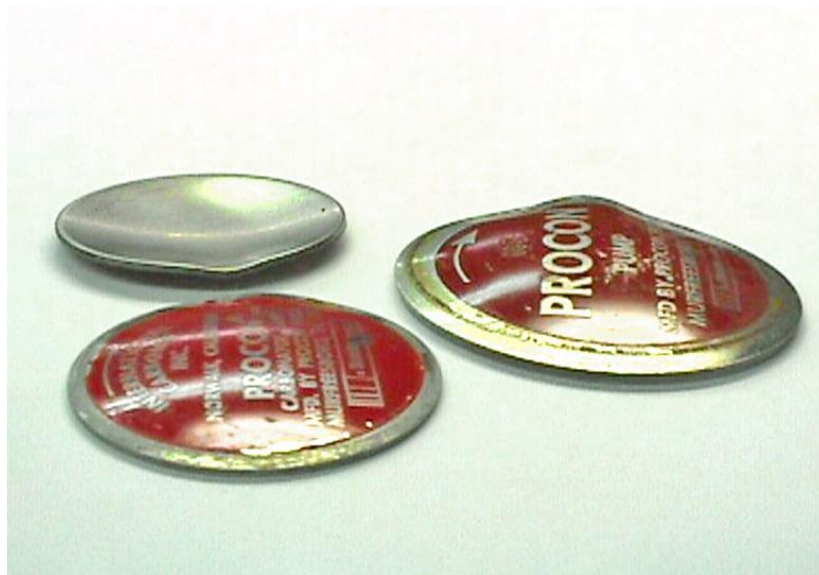
1. Check for physical deformities in the housing such as compression marks from the pump being placed incorrectly in a vise during fitting installation, flat spots on the outer diameter of the housing which occur when a pump is dropped, and signs of pump/motor misalignment which may have caused abnormal wear to the mounting flange on the pump as well as the pump shaft.
2. Inspect the nameplate for flatness. A nameplate that is bulged outward is a sure indication that the pump has been subjected to abuse. There are only two causes for a bulged nameplate. The most common cause is pump over-pressurization, which can occur when the pump is subjected to extreme high-pressure situations (generally in excess of 300 PSI). The nameplate may also bulge if liquid is left in the pump while the unit is exposed to freezing temperatures, causing the liquid to solidify and expand. See example below.

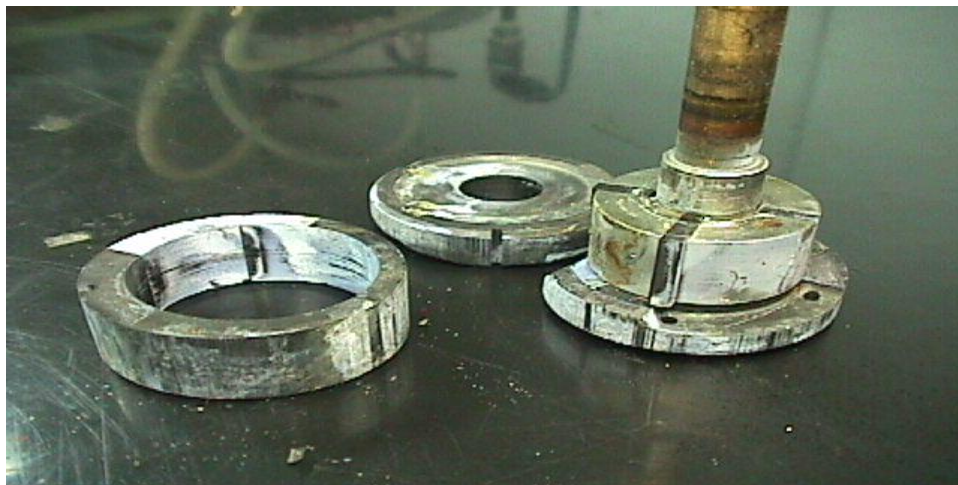
2. Look for signs of residue buildup on the internal components in the form of a chemical residue or a chalky mineral buildup. Such a condition may cause premature wear of the carbon graphite components and/or cause distortion of tolerances resulting in a pump which requires an abnormal amount of torque for proper operation. This may cause the motor overloads to trip or simply make the motor operate at a higher temperature than expected. Dissolved calcium and magnesium compounds mainly cause mineral residue and mineral buildup and deposits. The quantity of these compounds determines water hardness. They are found in all municipal and well water supplies in varying quantities. These compounds form deposits similar to limestone in pipes, water heaters, washers, and other fixtures, and also combine with soap to produce soap scum. These deposits build up in pipes, appliances, etc., which reduces water flow and interferes with operations. This buildup also distorts the tight internal tolerances in our pumps.

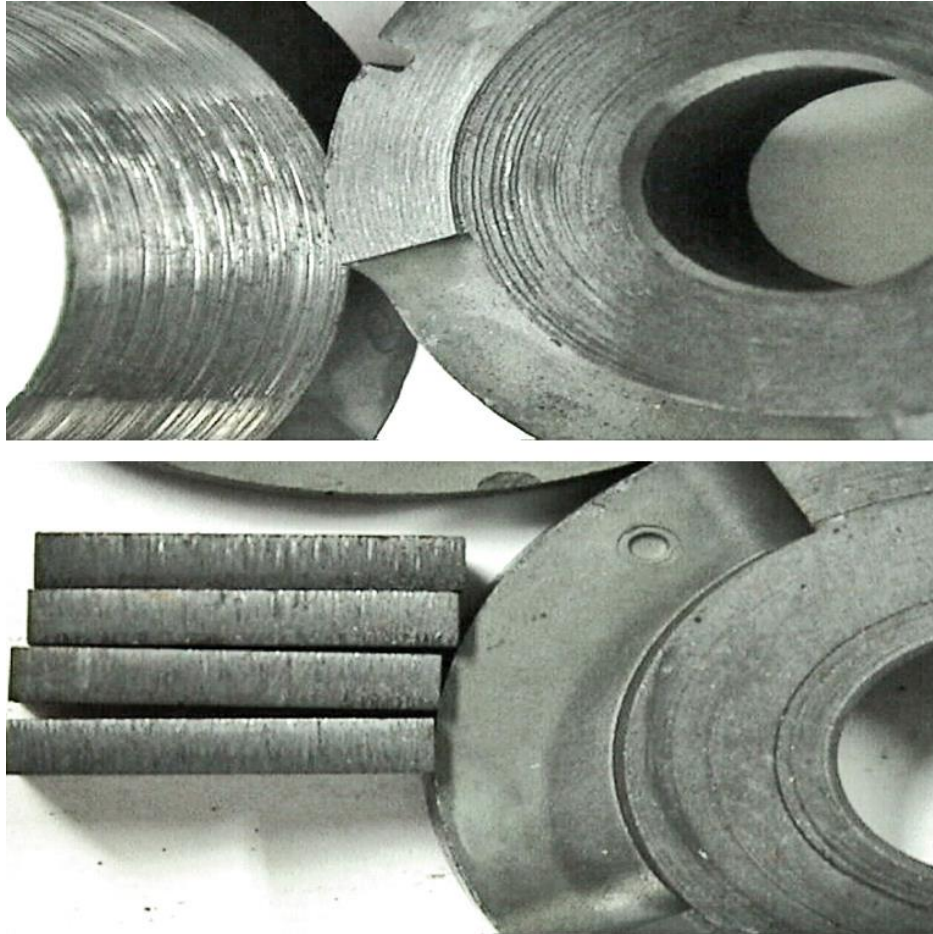
3. If proper filtration was not performed on the incoming fluid, it is possible that severe scoring could have occurred to many of the contacting surfaces within the pump. Look for signs of this on the rotor shaft journals, the I.D. of the carbon graphite bearings, the edge of each vane where it makes contact with the liner surface, the I.D. of the liner, and the mating surfaces of the mechanical face seal. When debris such as sand, silt or undissolved chemical has passed through the pump and

caused scoring to the components, it is likely the pump was no longer able to perform at high discharge pressures or deliver the proper amount of flow, due to the recirculation which could have occurred within the pump because the proper tolerances were no longer present. See examples below.

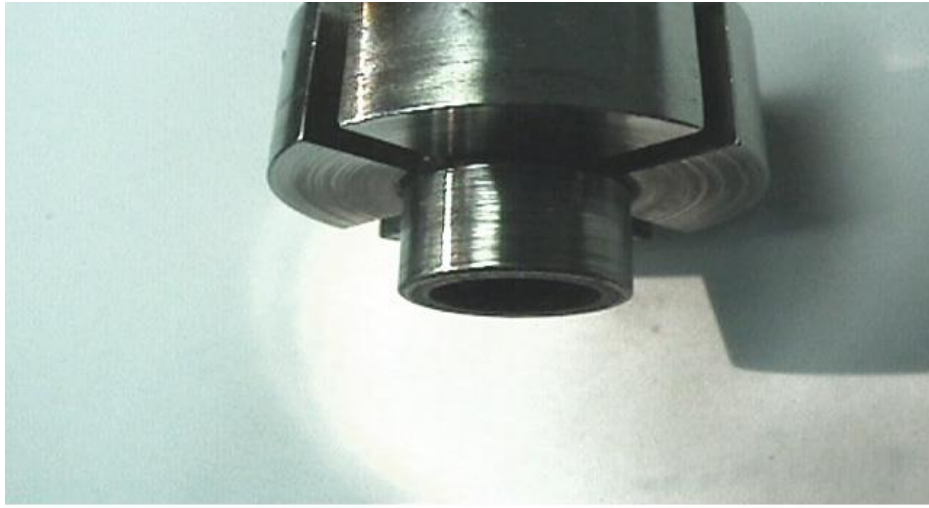
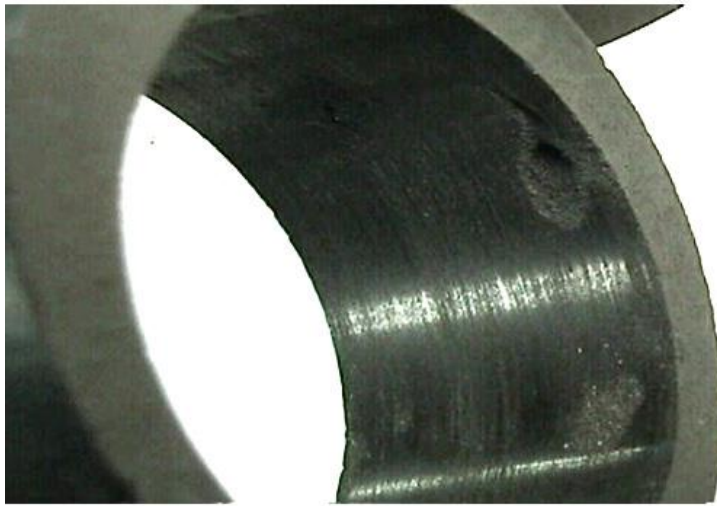
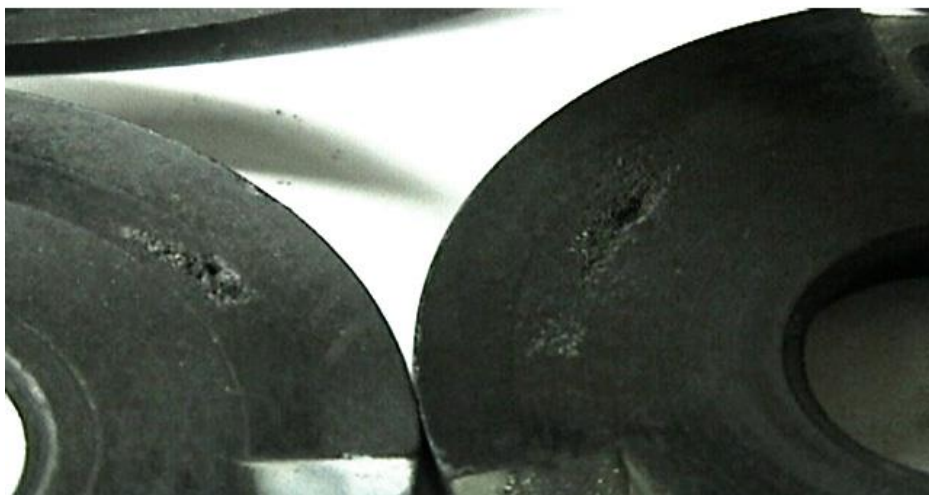
4. Because our pumps are positive displacement, it is imperative that an adequate amount of fluid be available to always feed the pump inlet. If there is a restriction of the incoming fluid flow to the pump in the form of a blocked pre-filter, inadequately sized I.D. piping, etc., cavitation may occur and cause a deterioration of the internal components. Generally if a pump is cavitating during operation, a chattering noise will be present and if there is a pressure gauge on the discharge line, a noticeable vibration of the needle may be detected. Whenever a customer mentions that a pump was noisy prior to its removal from the system, very often the problem was due to cavitation.

Cavitation is easily distinguishable during pump evaluation because if a pump has been harmed by a cavitation condition, there will be undeniable evidence of the damage. The damage is exhibited in the form of very small pits being present on one or more of the carbon graphite surfaces. Typically, the damage will be most obvious on the bearing and liner surfaces. Holding the components with the alignment pin notch at the 12:00 o'clock position, look for damage from the 3:00 o'clock position to the 8:00 o'clock position. Depending on the severity of the damage, very small holes may be present or many small holes may have been created forming deep craters in the surface. No other condition will leave behind this type damage. See example below.

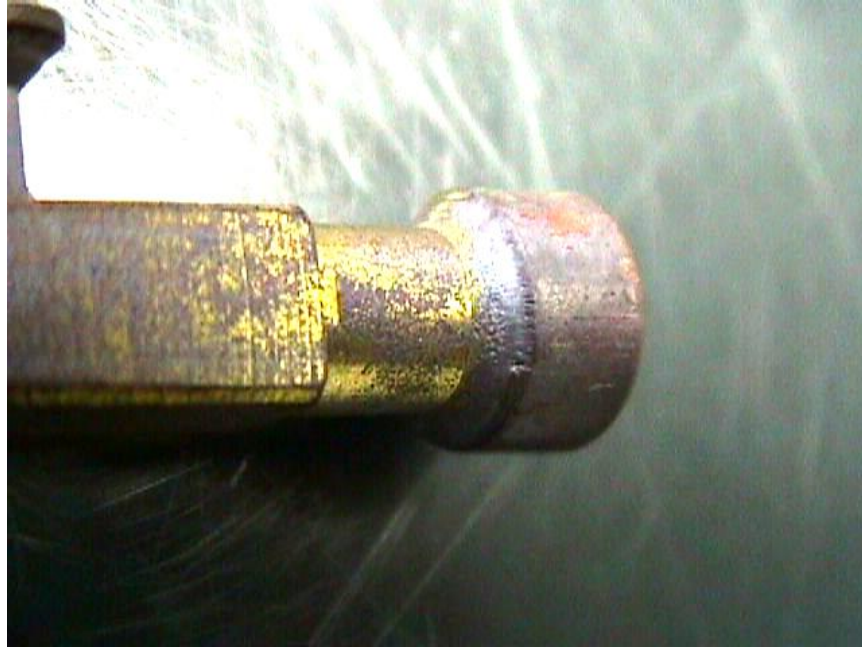
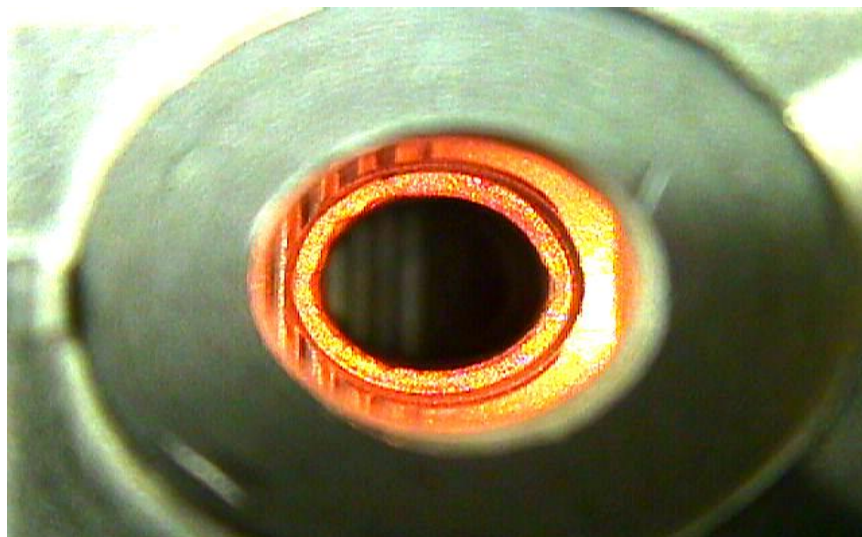
7. Constant internal recirculation through the relief valve or operating the pump less than 50psi below the relief valve setting, will result in damage to the relief valve housing seat and the valve itself. This damage is visible on both valve seat and valve in the form of removed/eroded brass material. Loss of flow and pressure is the failure mode in this situation. See example below.
