Valve Failure

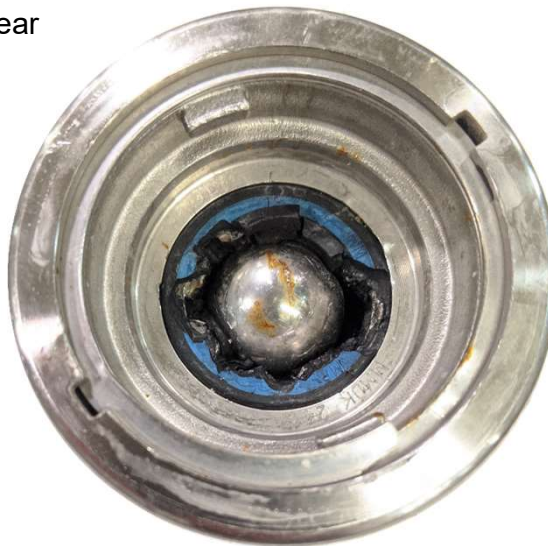
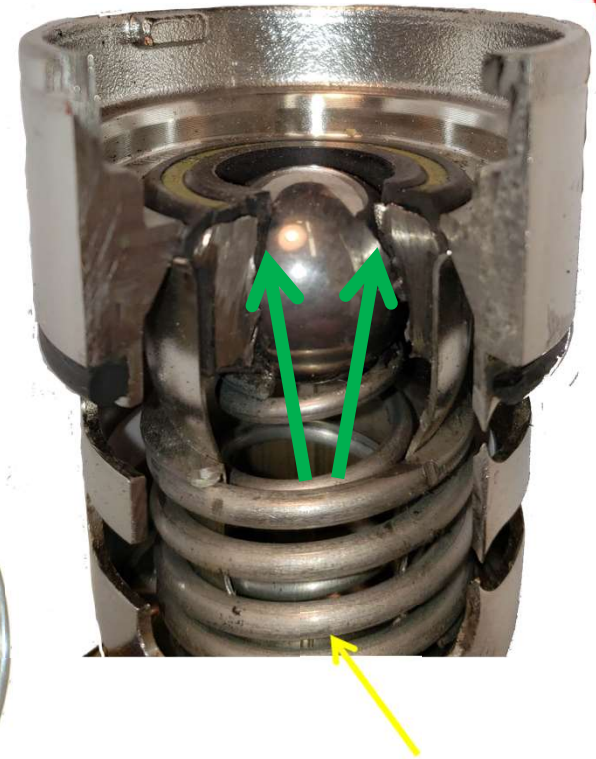
1. Beer Leakers

Symptoms - Beer leaks from the interface between the beer valve (ball or poppet) and the CO₂ Valve, usually due to damage to either valve in the form of cuts, gouges, or dry rot.

In-market causes are most often related to damaged or carelessly used keg couplers. Couplers with burrs or sharp edges on the beer probe can cause damage to both beer and CO₂ Valves. Damage is even worse when couplers are carelessly engaged.

In-brewery causes include damaged couplers, poorly designed or maintained keg wash/fill equipment which may impact, cut, or gouge valve parts, and overfilled kegs with little or no headspace.

Remedies typically involve disassembly of the spear and replacement of the damaged components, requiring special tools and training, or simply replacing the entire spear as a unit.

Prevention – Good design and maintenance of draft packaging and dispense equipment and observance of proper fill levels

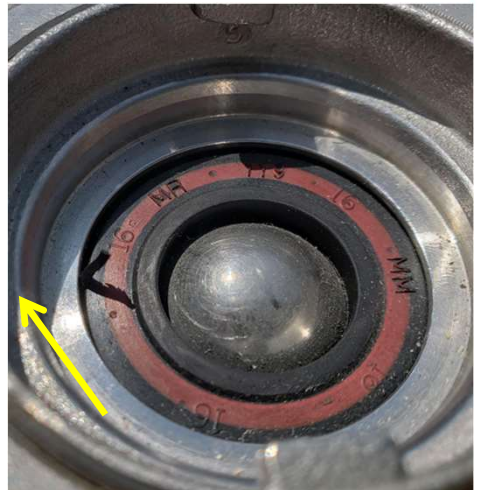
Figure 2

Causes – The most common are foreign objects stuck in the interface between the CO₂ valve and the spear body (fig 2). These objects include dry hops, splinters & char from barrels, and scrubby pad threads & brush bristles from manual cleaning of the keg well. Sometimes overfilling, over-pressurization, or improper maintenance techniques can cause damage to the CO₂ valve resulting in gas leaks also (fig 3).

Remedies - Can often be as simple as flushing the foreign material out of the sealing area by sending the keg through the washer for an extra cycle or two.

Stubbornly lodged objects or damage to the CO₂ valve may require disassembly of the spear or replacement of the CO₂ valve.

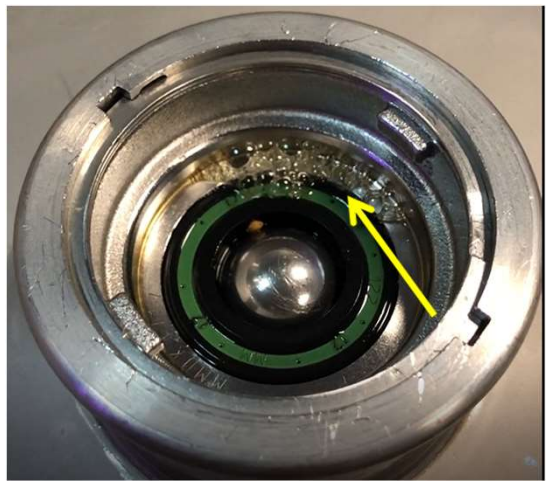
Figure 1

Symptoms - Gas leaks around the gas sealing surface at the outer diameter of the CO₂ valve. (fig 1)

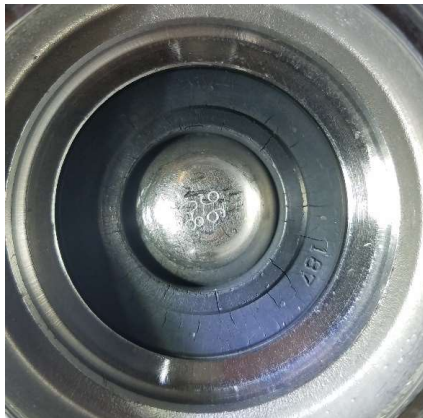
Causes - Similar to those for beer leakers. Kegs that have been stored with extended exposure to the sun are also prone to this type of failure due to cracking and dry rot. These problems will only be identified by observing valve damage during visual inspection at the brewery or by poor pouring performance in the market.

Cracked rubber from UV exposure (sunlight)

Remedies - Replacement of damaged CO₂ valves

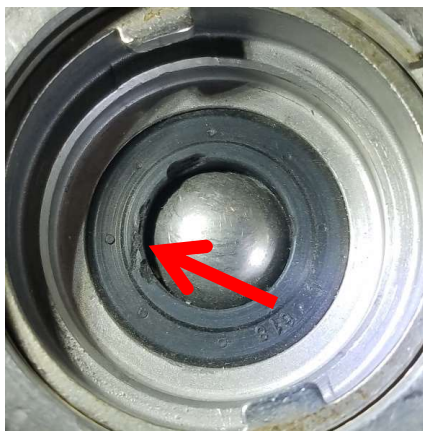
Symptoms - Beer foams at dispense without any identifiable cause associated with the dispense system. The raised rim around the inside diameter of the CO₂ valve is damaged, allowing gas to pass from the gas passage over into the beer stream.

Impact damage to raised rim on CO₂ Valve

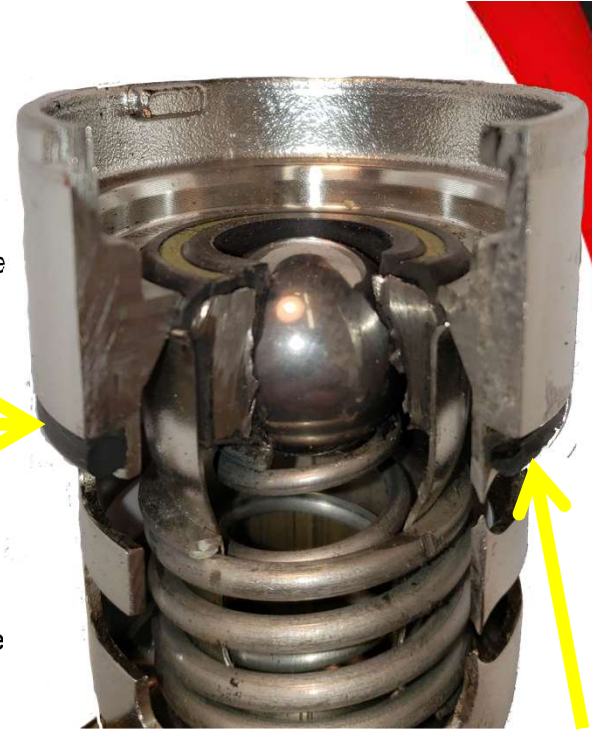
4. Neck Leaks

Symptoms - Beer or CO₂ seeping out at the top of the neck. This is a fairly rare occurrence in drop-in spears. It is much more common in threaded spears.

Causes - The O-ring (drop-in spears) or sealing ring (threaded spears), which seals the spear into the keg neck is degraded, damaged, or spear is loose.

Drop-in spears - Over-compression of the O-ring during installation or failure to wet the O-ring prior to installation, which results in damage to the seal.

Threaded spears - Leaks can occur as a result of insufficient application of torque during installation (~55 ft/lbs), failure to wet the sealing ring prior to installation, failure to periodically re-torque the spears (~35 ft/lbs), and loosening of the threaded connection caused by tampering or attempts to remove couplers which have become stuck in the spear.

Prevention - Wetting of all O-rings and sealing rings prior to installation, tightening and retightening threaded spears to specified torque settings.

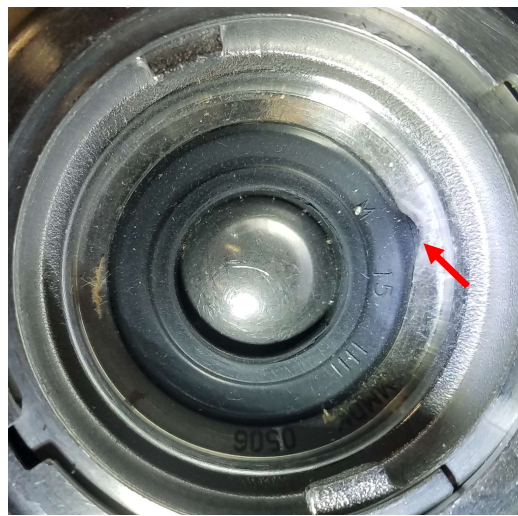
Figure 1

Symptoms - Rubber deteriorates and cracks, separating from the metal core inside of the valve, resulting in areas which may be uncleanable and harbor contaminants. Early symptoms can be difficult to identify but operators should look for flaps of rubber (fig. 1), or bubbled/swollen rubber (fig. 3). Valves with advanced delamination (fig.2) will often fail to drain when inverted and placed on the keg washer

Causes - This is most often found on very old valves (10+ years), valves that have been subjected to excessive steam or chemicals during cleaning and sanitation, or stored in exposure to UV (sunlight). This failure can often be identified by a failure of kegs to drain properly on the keg washer. Visual signs of delamination are shown, but may not be evident until well after these have become a QA/QC risk.

Remedies - Replacement of the CO₂ valve is required once this damage has occurred.

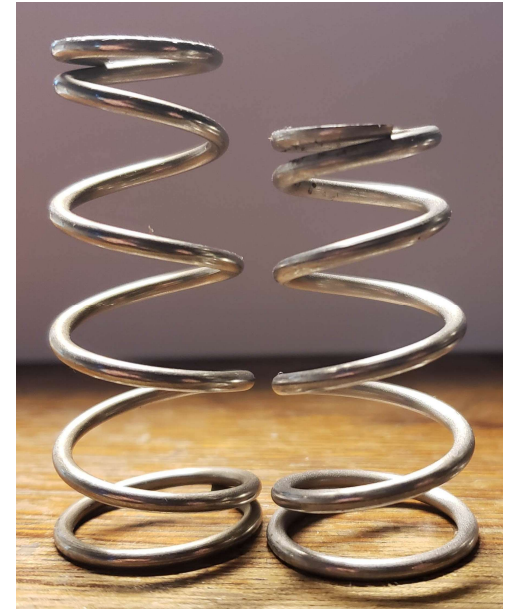
6. “Seeper” Kegs

Weakened springs in the valves cause the beer valve (ball or poppet) to seat poorly or bounce when the kegs are moved. These kegs will leak/seep/“burp” small amounts of beer into the well unpredictably.

Causes - Springs are weakened prematurely due to over-stroking (over-compression) caused by poorly designed wash probes, through normal wear-and-tear, or due to spears being rebuilt using worn springs.

Remedies - Replace damaged or worn springs

Prevention - Make sure that your keg washer is equipped with wash probes designed to stroke the beer and CO2 valves the correct distances and that the machine is properly adjusted for stroke.

Rebuild spears as part of a preventive maintenance program which includes replacement of worn or damaged springs. A partial rebuild may lead to difficult to track nuisance seepage.
