Valve Failure

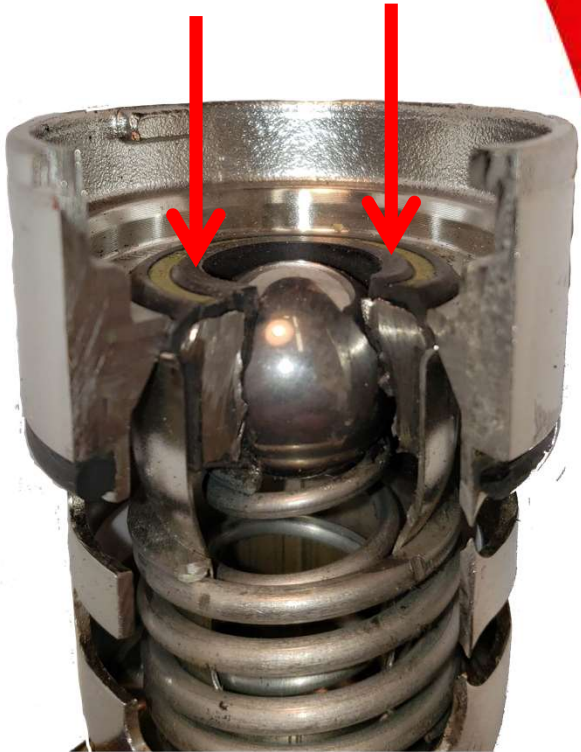
Symptoms - Beer foams at dispense without any identifiable cause associated with the dispense system. The raised rim around the inside diameter of the CO₂ valve is damaged, allowing gas to pass from the gas passage over into the beer stream.

Causes - Similar to those for beer leakers. Kegs that have been stored with extended exposure to the sun are also prone to this type of failure due to cracking and dry rot. These problems will only be identified by observing valve damage during visual inspection at the brewery or by poor pouring performance in the market.

Impact damage to raised rim on CO₂ Valve

Remedies - Replacement of damaged CO₂ valves

Prevention is the critical issue here, involving proper identification of the problem before the keg leaves the brewery. This can only be accomplished by good training for keg technicians to identify any damage and pull kegs out of service before they can return to market.

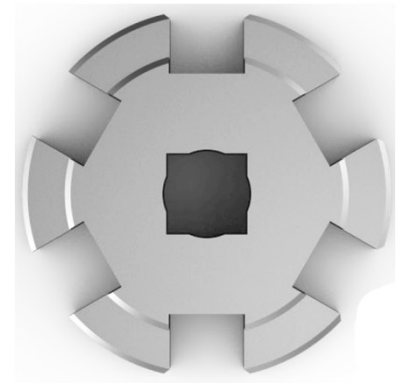
Torque Wrench Adapter for Threaded Spears

Threaded spears - Leaks can occur as a result of insufficient application of torque during installation (~55 ft/lbs), failure to wet the sealing ring prior to installation, failure to periodically re-torque the spears (~35 ft/lbs), and loosening of the threaded connection caused by tampering or attempts to remove couplers which have become stuck in the spear.

Prevention - Wetting of all O-rings and sealing rings prior to installation, tightening and retightening threaded spears to specified torque settings.
